DECEMBER 2025 MONTHLY ECO AUDIT REPORT

IMPOFU CLUSTER WIND ENERGY FACILITY

DOCUMENT TITLE: December 2025 Monthly ECO Audit Report

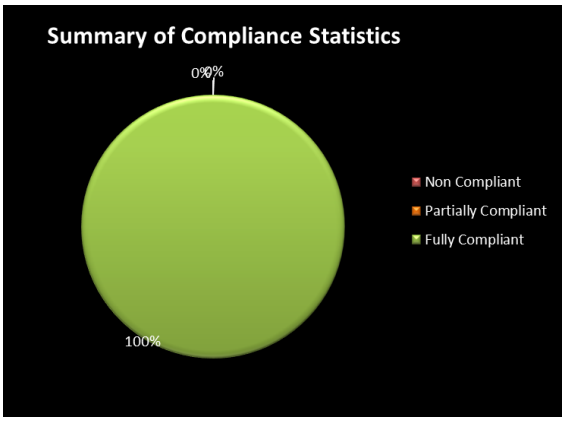
Figure 20: Summary of compliance with the requirements of the Impofu West EA (Power Construction).

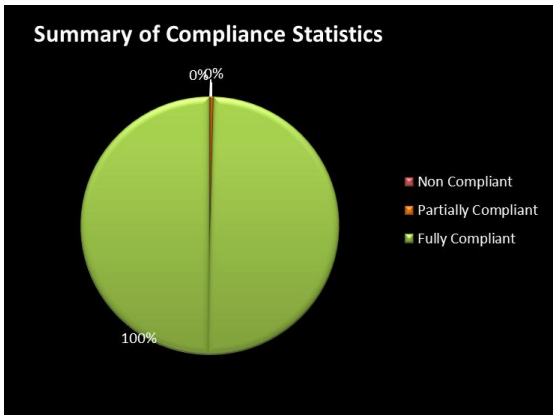
Figure 21: Summary of compliance with the requirements of the Impofu West EMPr (Power Construction).

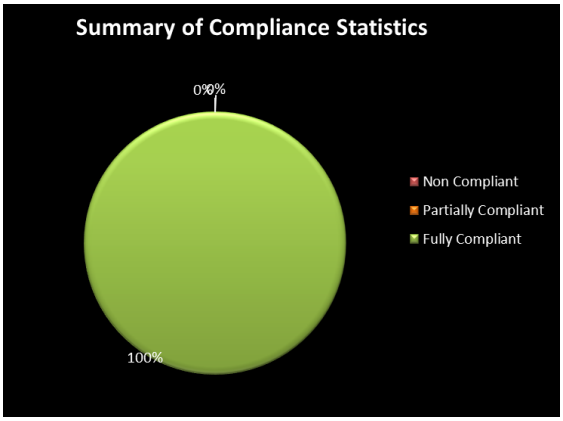
Figure 22: Summary of compliance with the requirements of the Impofu East EA (Power Construction).

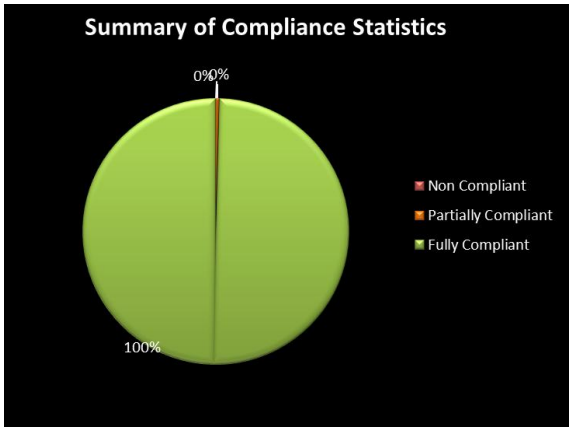
Figure 23: Summary of compliance with the requirements of the Impofu East EMPr (Power Construction).

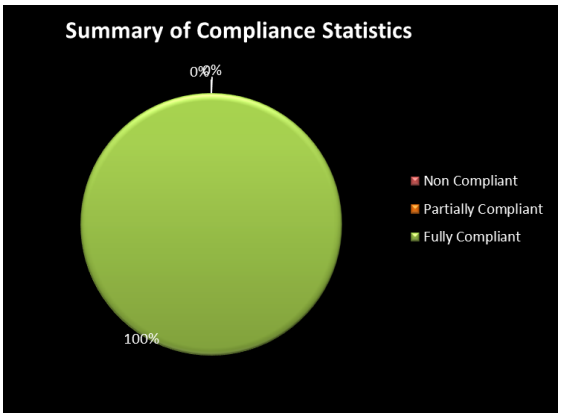
Figure 24: Summary of compliance with the requirements of the Impofu North EA (Power Construction).

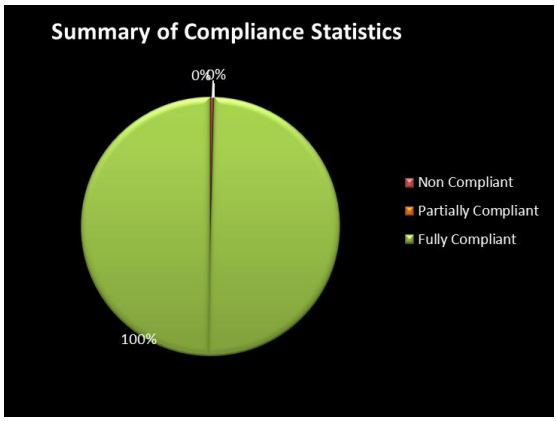
Figure 25: Summary of compliance with the requirements of the Impofu North EMPr (Power Construction).

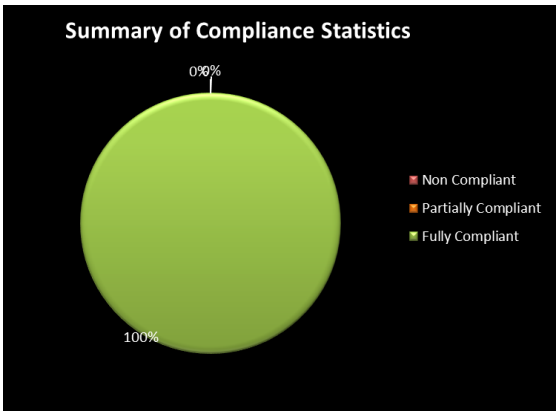
Figure 26: Summary of compliance with the requirements of the Impofu North EA (Nordex).

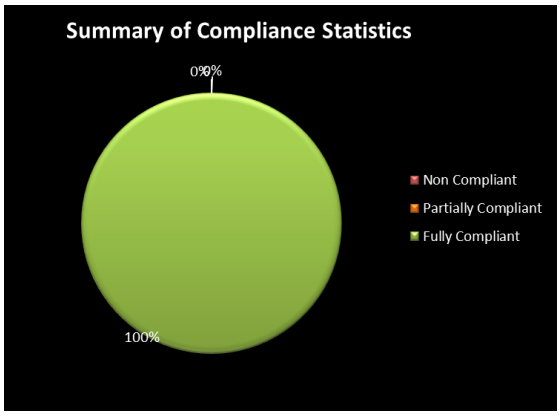
Figure 27: Summary of compliance with the requirements of the Impofu North EMPr (Nordex).

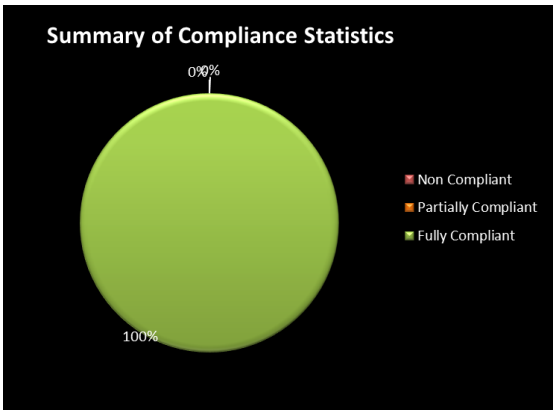
Figure 28: Summary of compliance with the requirements of the Impofu West EA (Nordex).

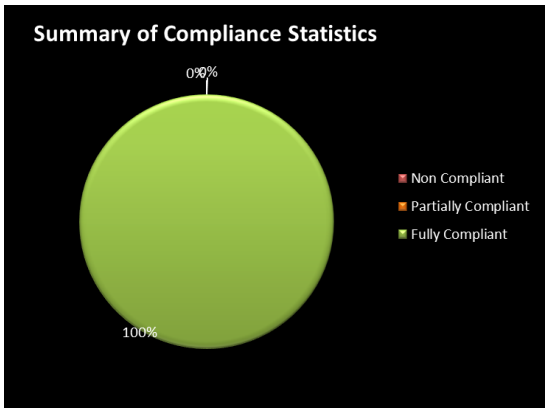
Figure 29: Summary of compliance with the requirements of the Impofu West EMPr (Nordex).

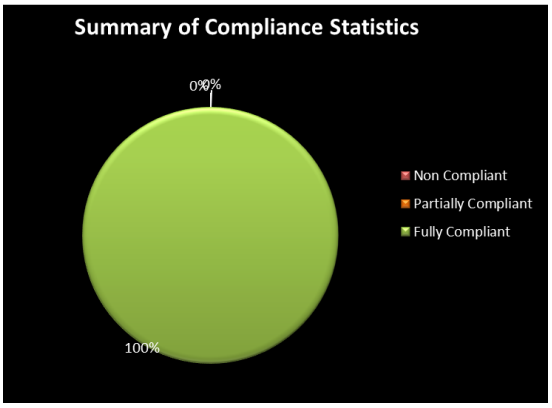
Figure 30: Summary of compliance with the requirements of the Impofu East EA (Nordex).

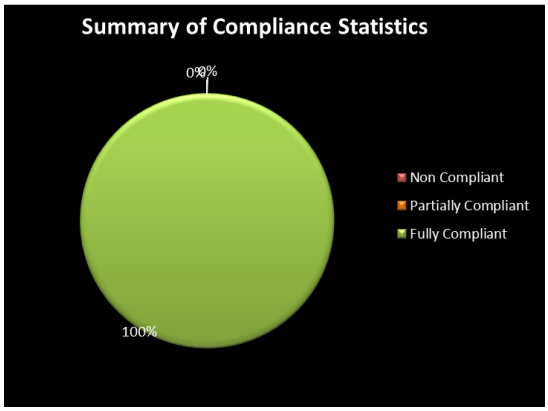
Figure 31: Summary of compliance with the requirements of the Impofu East EMPr (Nordex).

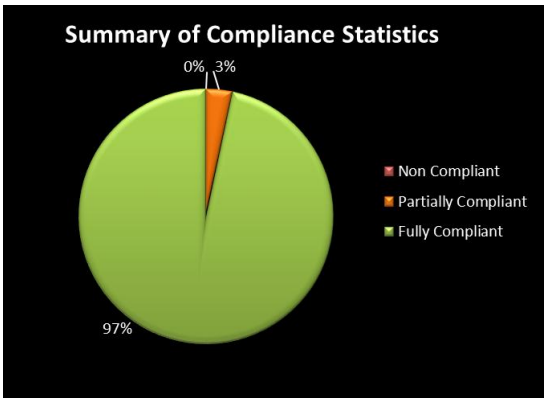
Figure 32: Summary of compliance with the requirements of the Buffer Yard EA (Nordex).

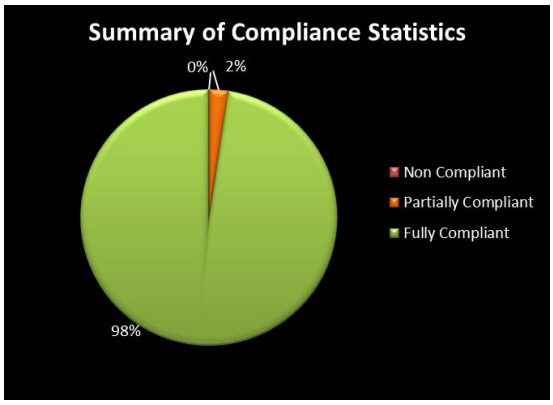
Figure 33: Summary of compliance with the requirements of the Buffer Yard EMPr (Nordex).

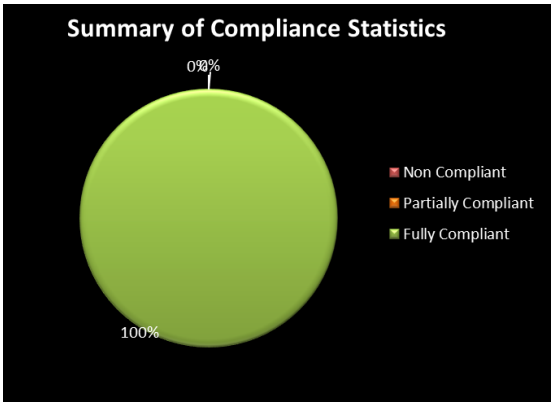
Figure 34: Summary of compliance with the requirements of the Substations EMPr (Brand Besamandla).

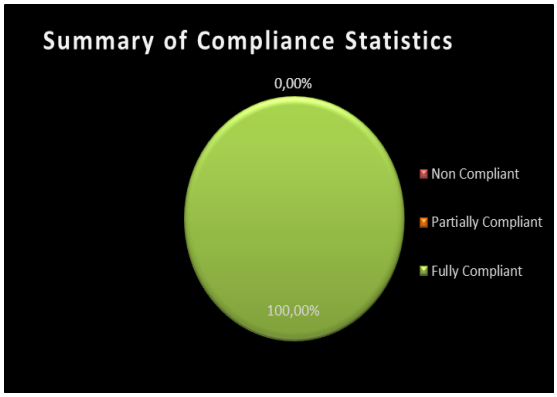
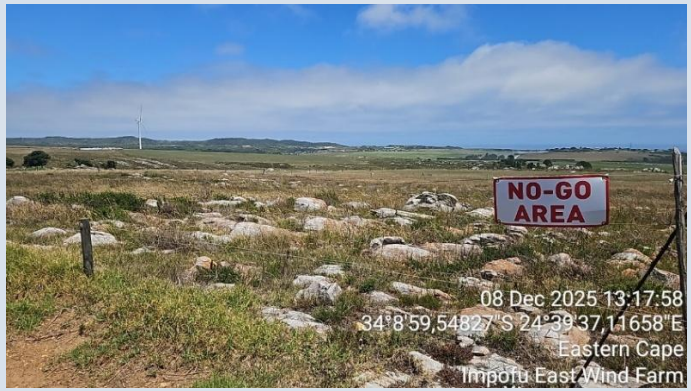
Figure 35: Summary of compliance with the requirements of the Water Use Authorisations (GA) (Power Construction).
