MARCH 2026 MONTHLY ECO AUDIT REPORT

IMPOFU CLUSTER WIND ENERGY FACILITY

DOCUMENT TITLE: March 2026 Monthly ECO Audit Report

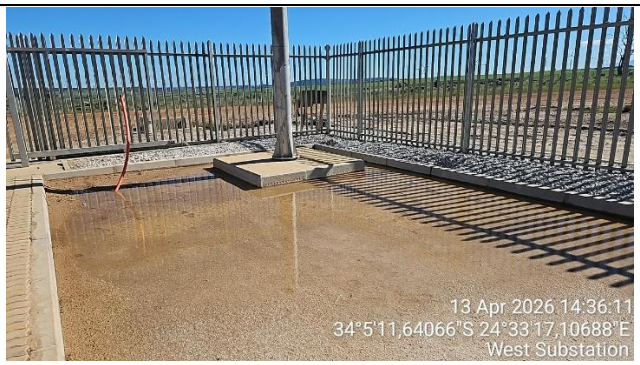
Figure 9: Water ponding at West substation

- Water ponding around the substation platforms and v-drains on site was observed to be prevalent following rain events. The culvert at West substation, for instance, was observed to have standing water for at least three days after rainfall. The contractor indicated that trapezoidal drains will be sloped as part of regular maintenance works. Where drains are identified to be ineffective maintenance will be conducted.

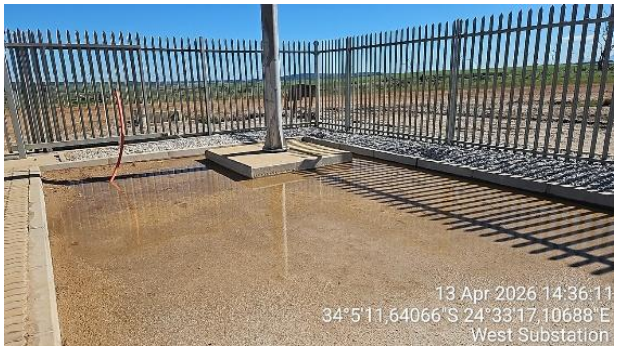
Figure 42: Water ponding still prevalent at West substation
