MAY 2024 MONTHLY ECO AUDIT REPORT

IMPOFU CLUSTER WIND ENERGY FACILITY

DOCUMENT TITLE: May 2024 Monthly ECO Audit Report

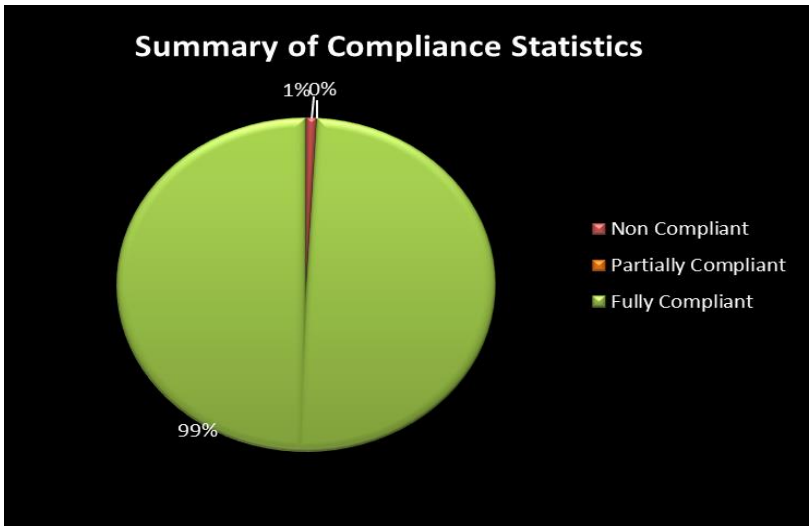
Figure 9: Summary of compliance with the requirements of the EA.

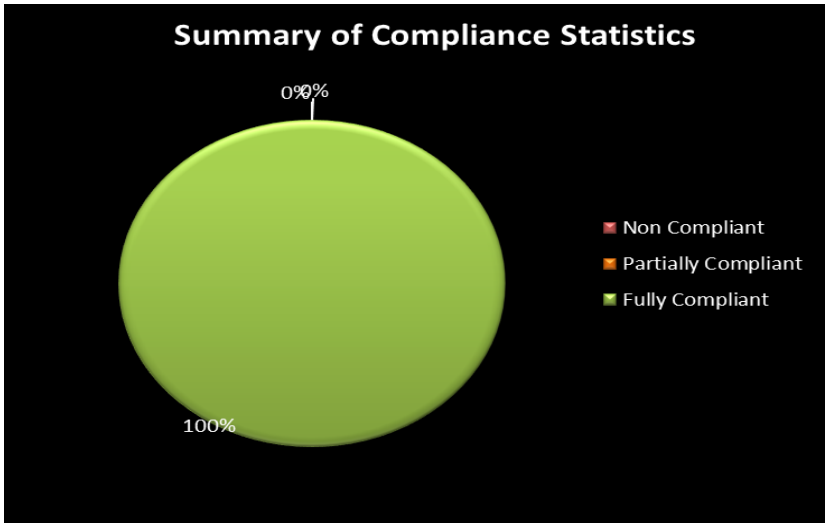
Figure 10: Summary of compliance with the requirements of the EMPr.

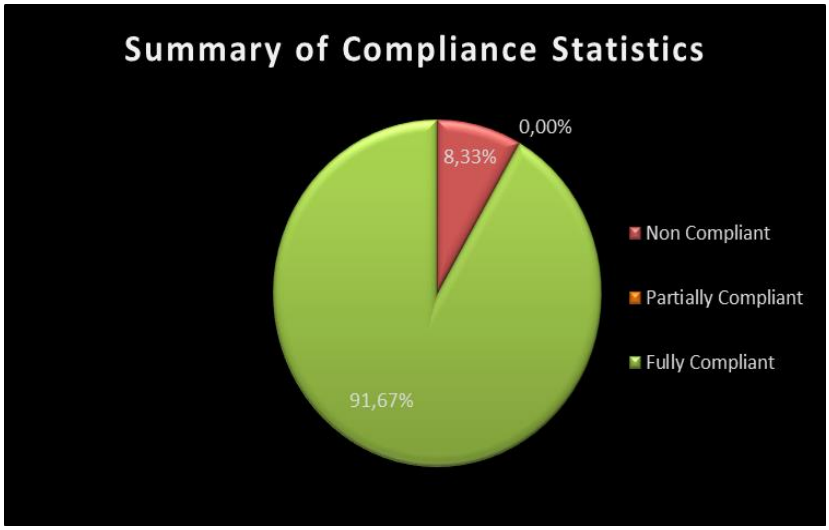
Figure 11: Summary of compliance with the requirements of the Water Use Authorisations (GA).
