JULY 2024 MONTHLY ECO AUDIT REPORT

IMPOFU CLUSTER WIND ENERGY FACILITY

DOCUMENT TITLE: July 2024 Monthly ECO Audit Report

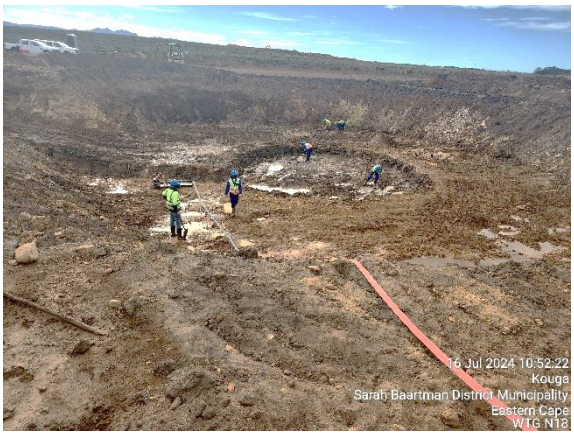
Figure 2: Preparations for ducting at WTG N18

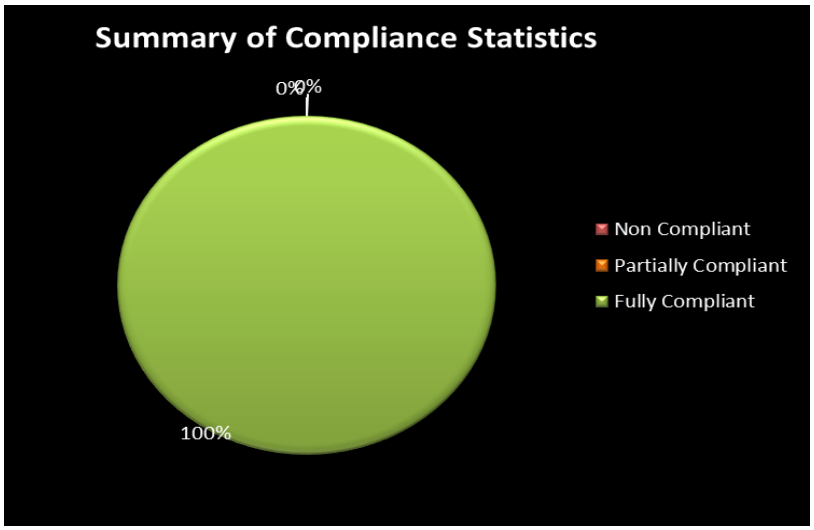
Figure 10: Summary of compliance with the requirements of the EA.

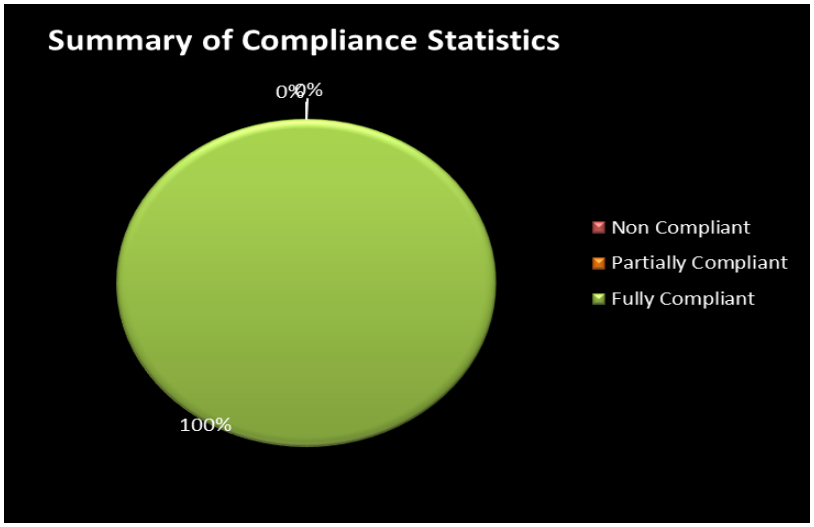
Figure 11: Summary of compliance with the requirements of the EMPr.

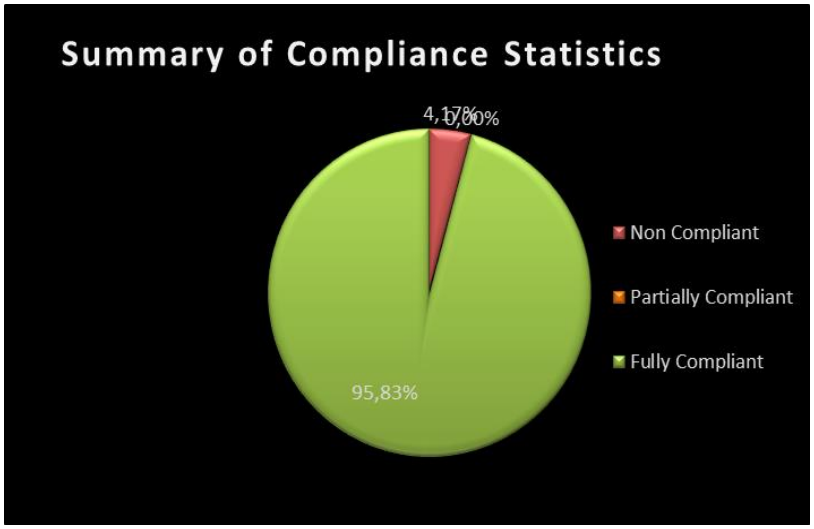
Figure 12: Summary of compliance with the requirements of the Water Use Authorisations (GA).
